Cluster Array - Failure

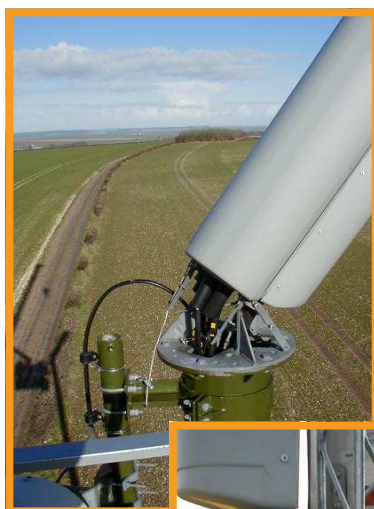
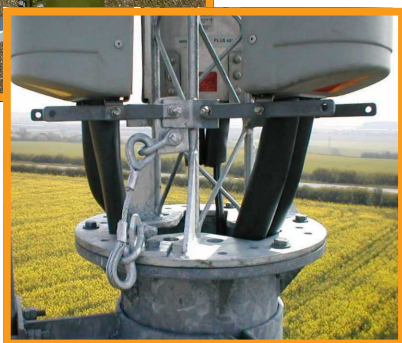
Following a reported failure at a base station site, a Swann Services team found a partial collapse of the column head-frame supporting the cluster of sector antennas. A preliminary inspection identified a potential fault with a structural member within the head-frame that could effect other sites.

Swann Services was retained to identify similar installations around the UK and to fit restraining devices that would prevent any further failures resulting in antennas falling to the ground.

Swann Consultancy Group was commissioned to design the replacement head-frame by the original equipment supplier. Subsequently the network operator contracted Swann Services to carry out the replacement works on sites.
